Tree Inventory and Preservation Plan Report 45 Grenoble Drive Toronto, Ontario

10 December 2024

KUNTZ FORESTRY CONSULTING INC Project P4301

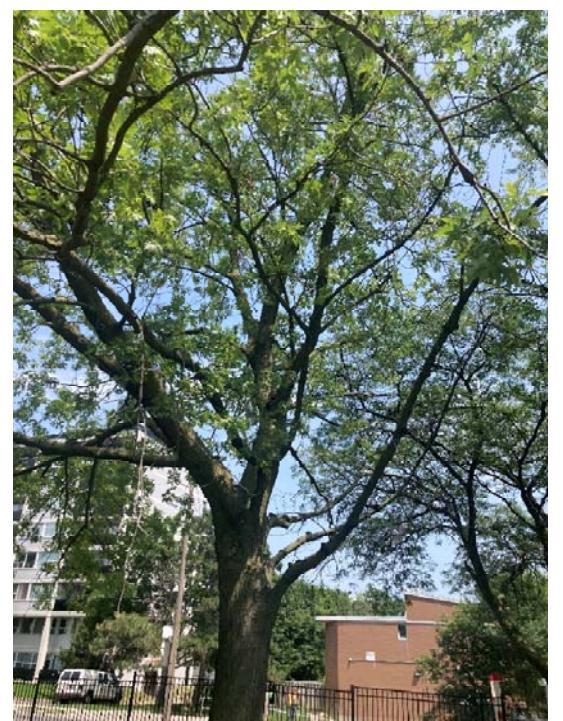
Image 4. Tree 168

The removal of 11 trees, including Trees 160, 167, 168, and 184-191, is required to accommodate the proposed development. Trees 184-191 directly conflict with the proposed building footprint and associated underground parking. Tree 168 conflicts with the proposed landscaping and underground parking. Significant encroachment into the minimum tree protection zones (mTPZ's) of Trees 160 and 167 will be required to accommodate the proposed landscaping and amenity areas such that we do not anticipate these trees to tolerate this level of injury.

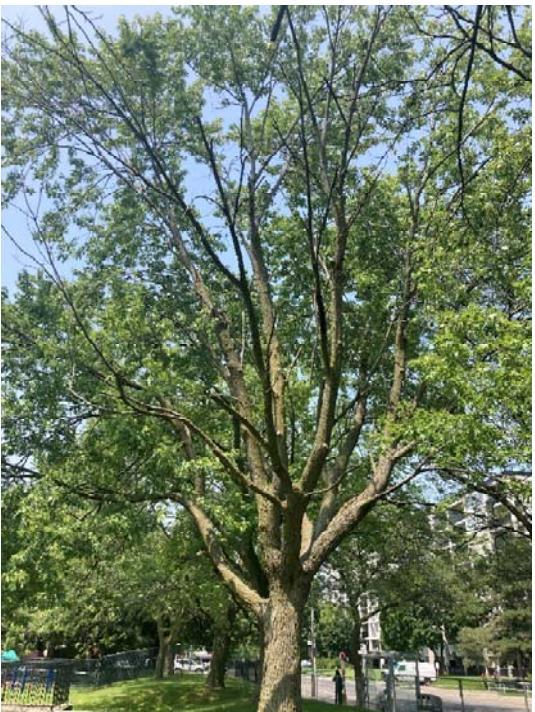
Image 12. Tree 188

188	Silver Maple	Acer saccharinum	65	F-G	P-F	P-F	30	10	4.2	1	Deadoowd (H), exposed roots (L)	Remove
189	Silver Maple	Acer saccharinum	33	F	Р	P-F	20	4	2.4	1	Union at 2m, lost leader, deadwood (L), poor form (M)	Remove
190	Silver Maple	Acer saccharinum	49	F	Р	Р	40	14	3.0	1	Poor form (M), one stem dead, deadwood (H)	Remove
191	Silver Maple	Acer saccharinum	89	F-G	F	F-G		14	5.4	1	Union at 2m, exposed roots (M), poor form (L), deadwood (L)	Remove
193	Siberian Elm	Ulmus pumila	40,41	F-G	F-G	G		12	3.0	1	Union at 0.8m, lean (L), exposed roots (L), bowing (L)	Preserve
A	Thornless Honey Locust	Gleditsia triacanthos inermis	45	F-G	F-G	F-G		10	3.0	5	Deadwood (vL)	Preserve
В	Thornless Honey Locust	Gleditsia triacanthos inermis	48	F-G	F-G	F-G		12	3.0	5	Deadwood (L)	Preserve
С	Thornless Honey Locust	Gleditsia triacanthos inermis	42	F-G	F-G	F-G		10	3.0	5	Union at 3m, poor form (L)	Preserve
D	Thornless Honey Locust	Gleditsia triacanthos inermis	47	F-G	P-F	F	15	10	3.0	5	Crook in stem (M), poor form (H), deadwood (M), union at 3m	Preserve

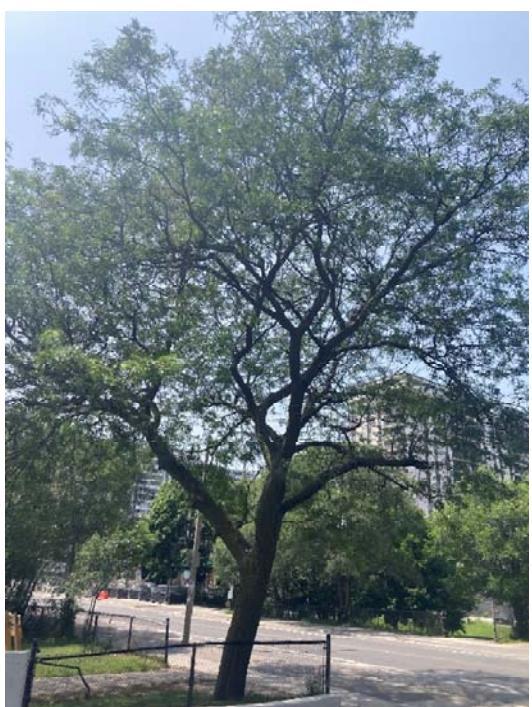
Image 18. Tree F

E	Thornless Honey Locust	Gleditsia triacanthos inermis	52	F	F	F-G		10	3.6	5	Lean (L), crook (M), poor form (M)	Preserve
F	Thornless Honey Locust	Gleditsia triacanthos inermis	~55	F-G	F-G	G		10	3.6	3	Pruning wounds (L), lean (L)	Preserve
